Inspection Report

Property Address:
123 Main Street
Houston TX 77007

I. STRUCTURAL SYSTEMS

A. Foundations

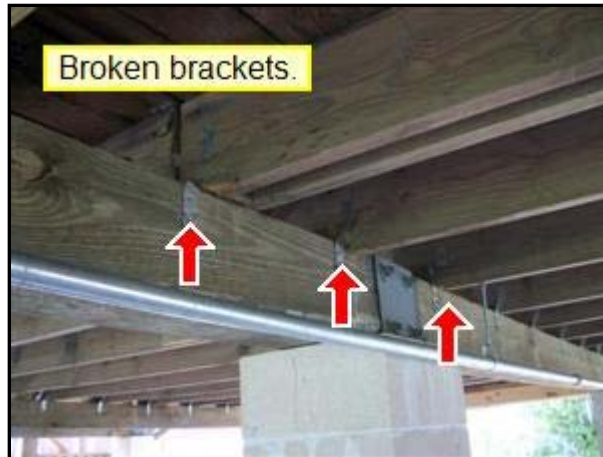
A. Picture 2

(3) Several engineering brackets are not properly installed throughout the floor joist and girder interface. They are either not completely engaged, missing or broken. These bracket should be replaced to ensure an even distribution of the load during windstorm conditions.

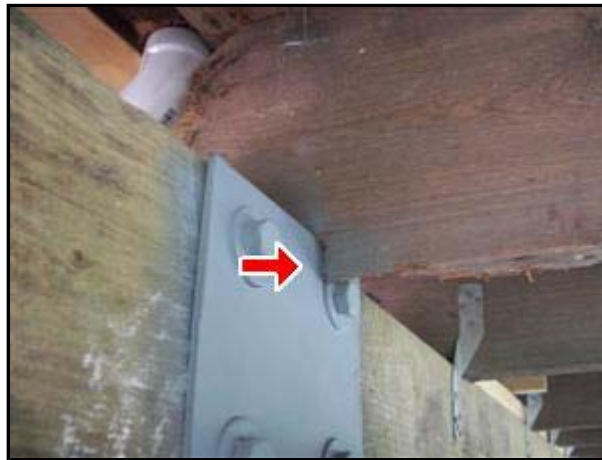
A. Picture 8

(6) The floor joist should not be located directly at the bracket. Also, the floor joist shows sign of deteriorated/rotting wood and should be replaced.

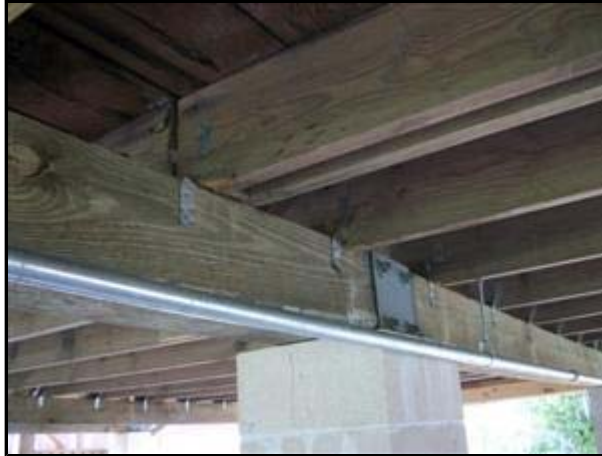
A. Picture 10

(7) Several pier along the back rows of the foundation; the girders are not properly secured to the piers. These bracket should be properly installed to ensure an even distribution of the load during

windstorm conditions.

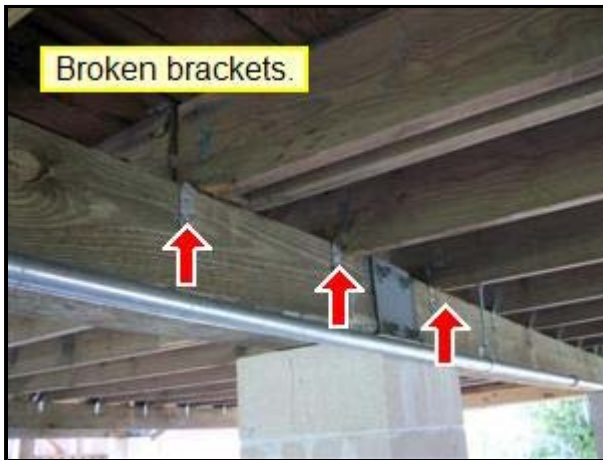
A. Picture 2

(3) Several engineering brackets are not properly installed throughout the floor joist and girder interface. They are either not completely engaged, missing or broken. These bracket should be replaced to ensure an even distribution of the load during windstorm conditions.

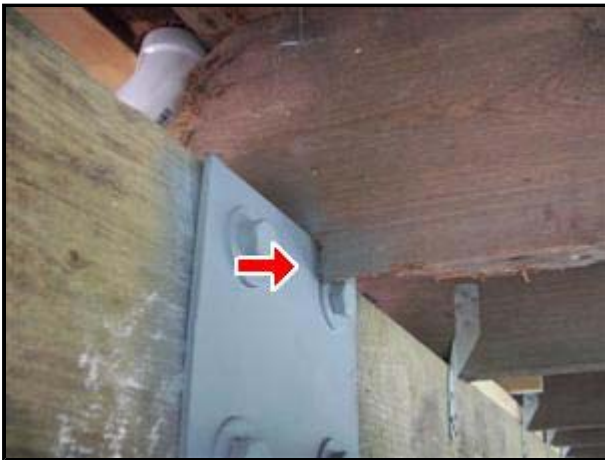
A. Picture 8

(6) The floor joist should not be located directly at the bracket. Also, the floor joist shows sign of deteriorated/rotting wood and should be replaced.

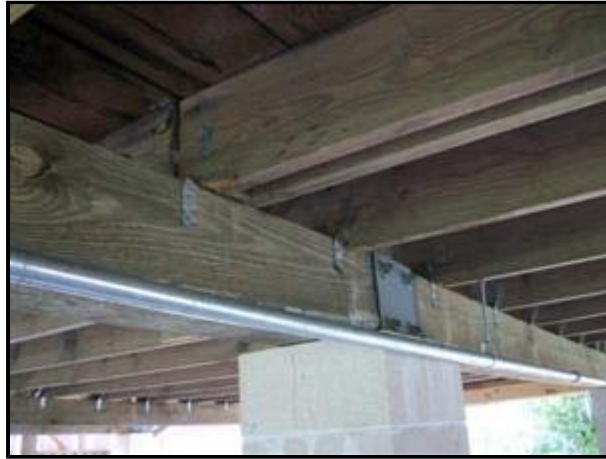
A. Picture 10

(7) Several pier along the back rows of the foundation; the girders are not properly secured to the piers. These bracket should be properly installed to ensure an even distribution of the load during windstorm conditions.
